READERS RESTORATIONS

STAR RESTORATION WINS £100
and Castrol goodies

1958 MGA 1500

Steve Giles, Lancashire

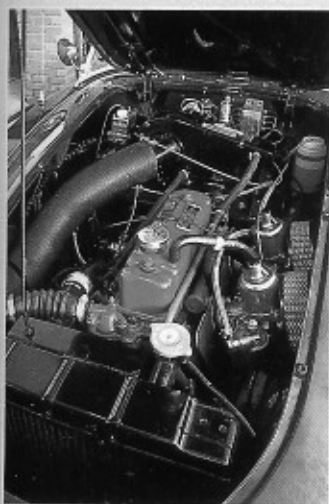
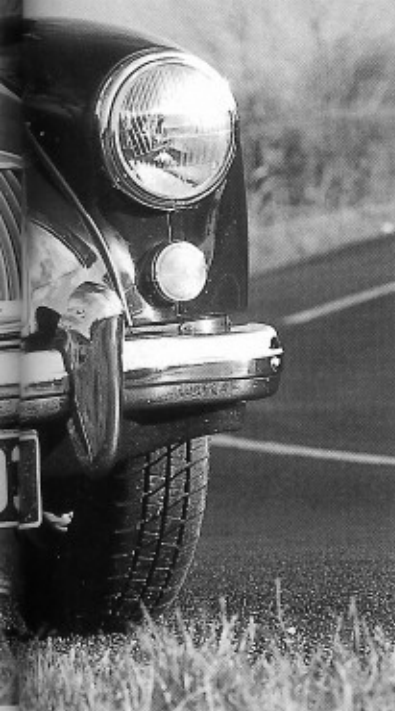
LEFT: Steve is delighted with his righthand-drive conversion and says steering is a delight.

BELOW: hours of painstaking work and plenty of money went into this superb engine bay.

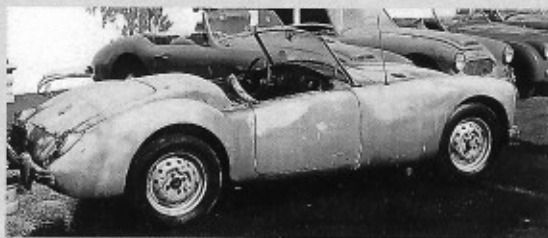
1 MG was shipped from the USA by Californian Classics. Steve didn't see the car, but this photograph persuaded him to part with £4500.

WHERE DID YOU GET IT? I bought it sight unseen from America. It had been taken off the road and stored in a barn for 20 years. Although it was solid, it was still in pretty poor condition overall. There was very little that didn't need rebuilding or replacing.

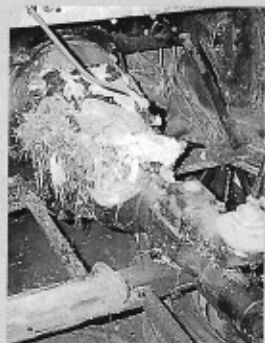
3 Mystery nest was thrown in free with the car. Steve had visions of waking a snake, so took it apart very carefully.

DID YOU FIND ANY NASTIES? The cylinder head in the boot was cracked, but I knew it had been removed and wasn't surprised. Amazingly, the engine wasn't seized despite being headless for all those years. The car also came with something extra in the shape of a nest in the gearbox tunnel. I was worried it might contain a poisonous snake and prodded it with a very long stick. Luckily, nobody was at home.

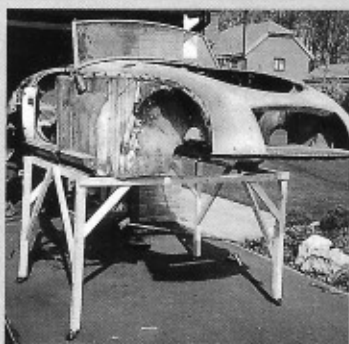
4 Home-made trolley looks fragile, but the bracing gave it sufficient strength to support body tub. Rolling chassis could pass underneath.

DID YOU WORK UNDER COVER? Yes, but it took some ingenuity. I have the luxury of a double garage, but half of it was taken up by the TC. So for the body tub, I built a trolley that straddled the chassis. This allowed me to move either body or chassis out of the garage to create more space.

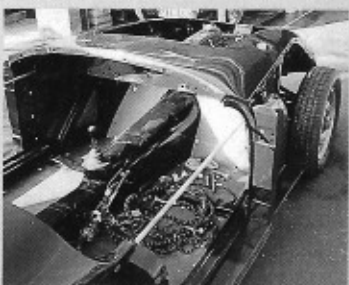
5 Because he didn't think his painting was up to the job, Steve had the top coat professionally sprayed before fitting a new floom.

HOW DID YOU GET ON WITH THE BODYWORK? I carried out most of this at a body refinishing evening class at Blackpool's Bispham Fylde College. I had the benefit of excellent tuition on panel stripping, etch priming, lead loading and filling, as well as the right equipment for two-pack painting.

PRETTY STRAIGHTFORWARD THEN? Not exactly. So much hard slog went into the preparation that I can well understand why many projects are offered for sale with only the rolling chassis completed. The worst part for me, in common with many other MGA restorers, was getting the panel fit right. I'm still not entirely happy with it.

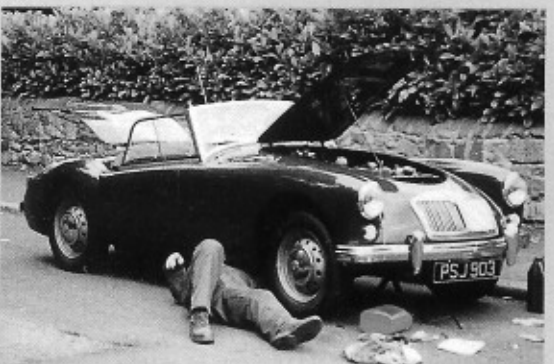
6 Not the most successful of starts. First major run (to MGCC Silverstone meeting) ended with a huge oil leak after just 38 miles. ➔

HOW WAS YOUR FIRST DRIVE? Not an unmitigated success. I got 38 miles down the MG before the oil pressure disappeared. I made the mistake of fitting a new oil canister O-ring without removing the original. My pride wouldn't allow me to call for roadside recovery.
